**DISTRICT OF COLUMBIA**  
**DRAFT**  
**TOTAL MAXIMUM DAILY LOADS**  
**for**  
**TOTAL SUSPENDED SOLIDS**  
**in**  
**WATTS BRANCH**

**DEPARTMENT OF HEALTH**  
**ENVIRONMENTAL HEALTH ADMINISTRATION**  
**BUREAU OF ENVIRONMENTAL QUALITY**  
**WATER QUALITY DIVISION**  
**WATER QUALITY CONTROL BRANCH**

**FEBRUARY 2003**

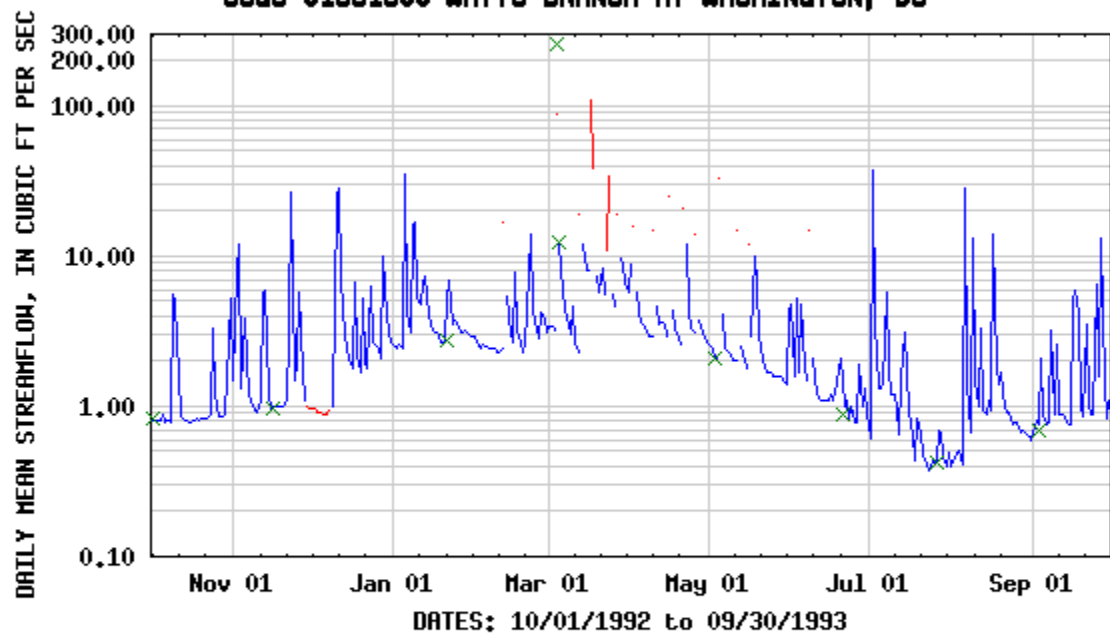
# USGS 01651800 WATTS BRANCH AT WASHINGTON, DC

— DAILY MEAN STREAMFLOW × MEASURED STREAMFLOW — ESTIMATED STREAMFLOW

The USGS, with cooperation from the Department of Health, is operating an active gage station on Watts Branch, located 200 feet upstream from Minnesota Avenue. The gage station was established in June 1992 and has a drainage area of 3.28 square miles. The average mean annual discharge is 4.48 cubic feet per second (cfs), with the lowest and highest mean annual discharge of 2.84 cfs and 5.87 cfs, respectively. The lowest measured flow is 0.28 cfs and the highest peak flow is 1510 cfs.

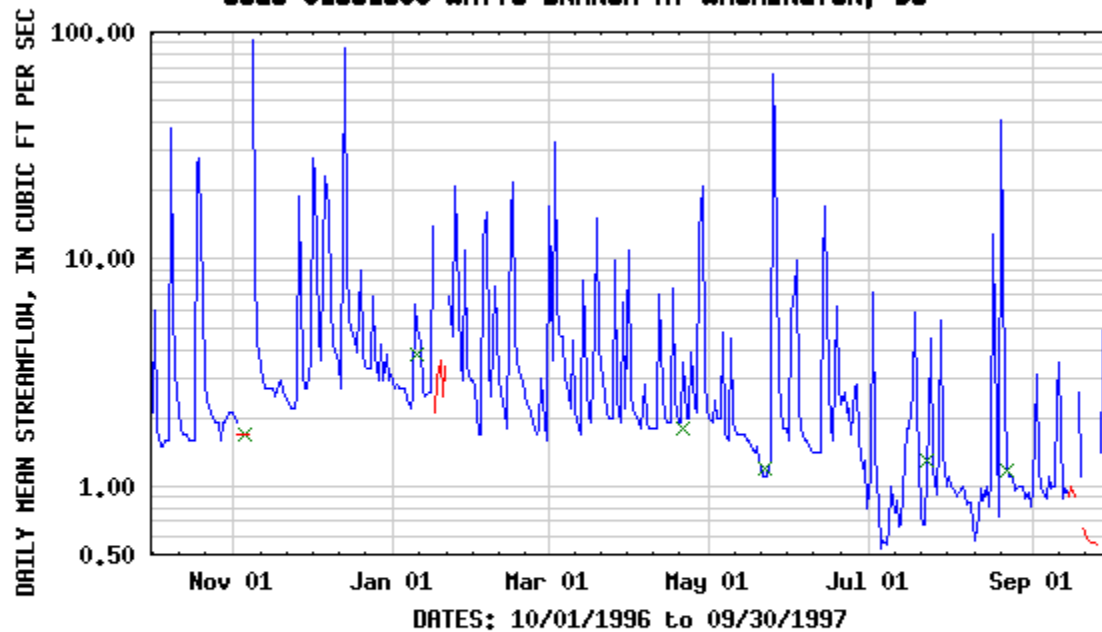
# USGS 01651800 WATTS BRANCH AT WASHINGTON, DC

— DAILY MEAN STREAMFLOW × MEASURED STREAMFLOW — ESTIMATED STREAMFLOW

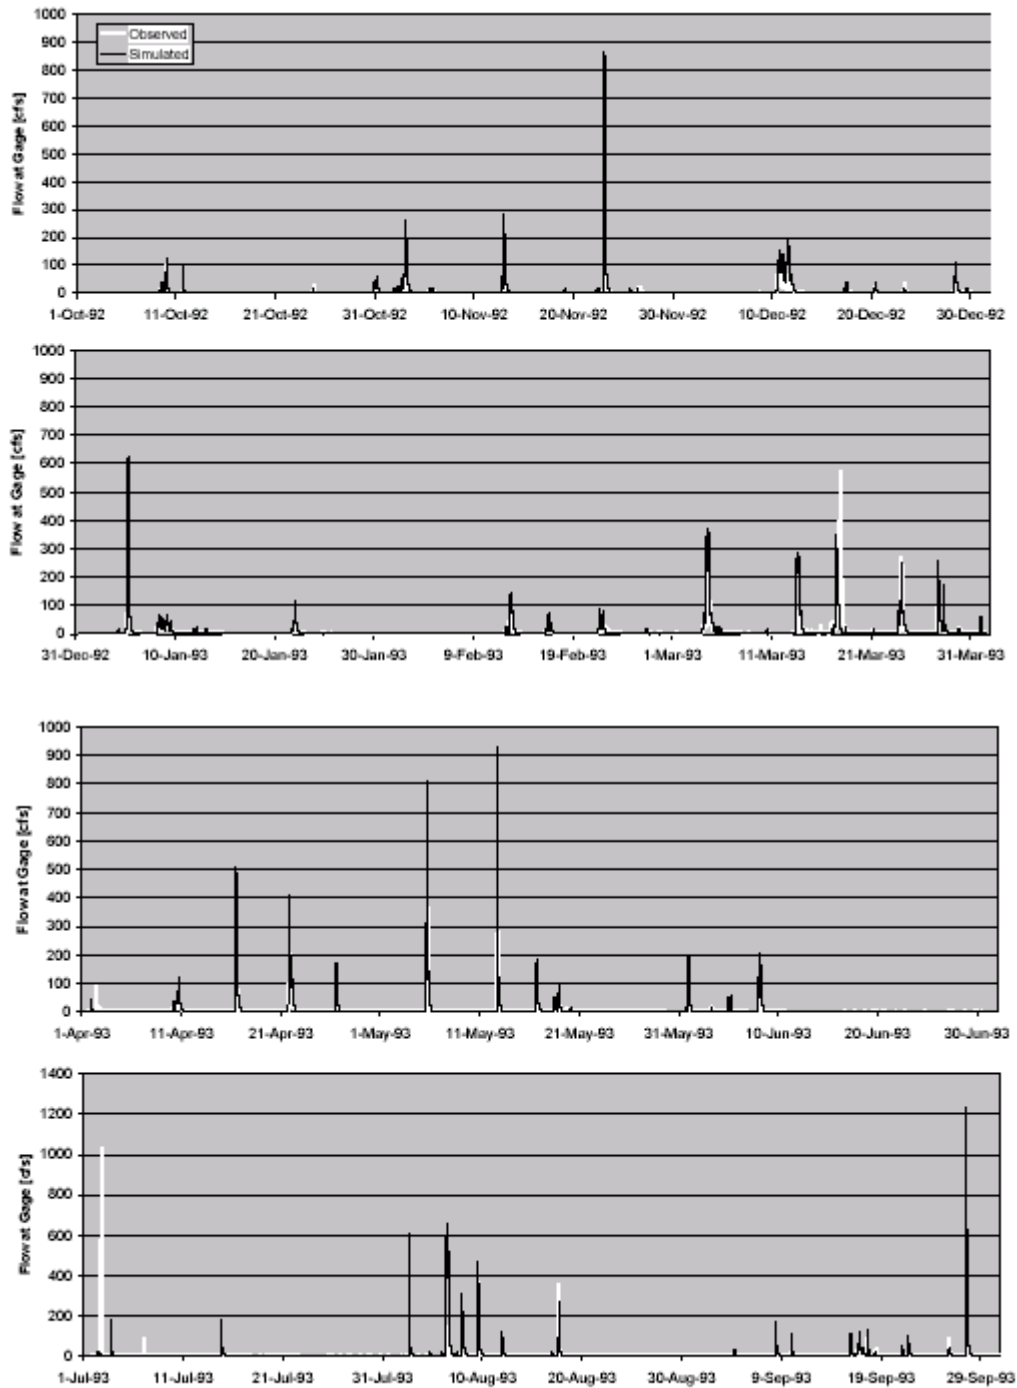
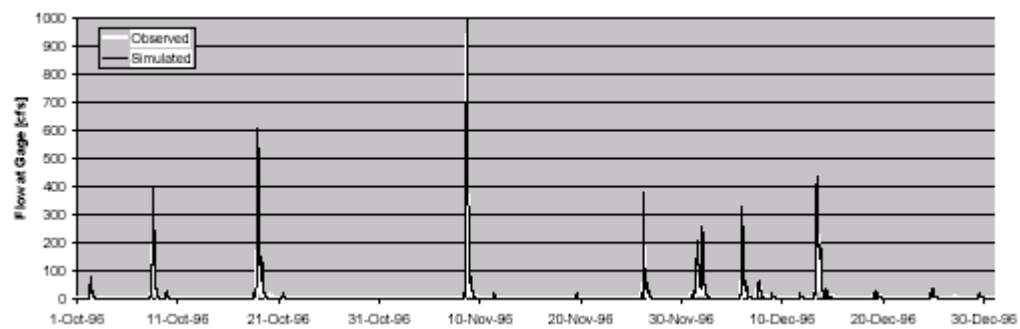
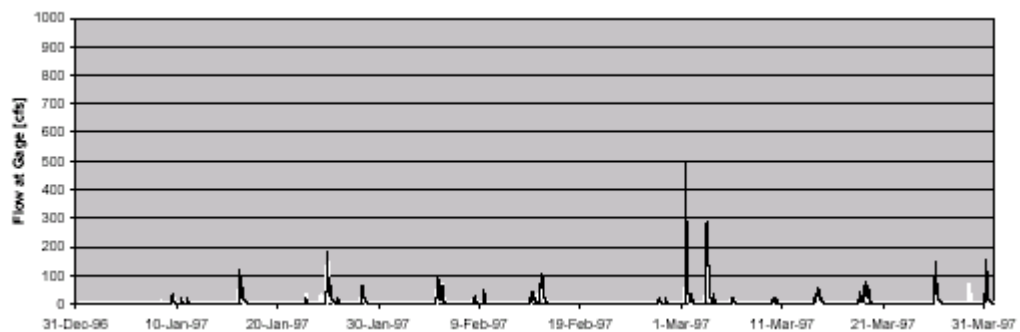
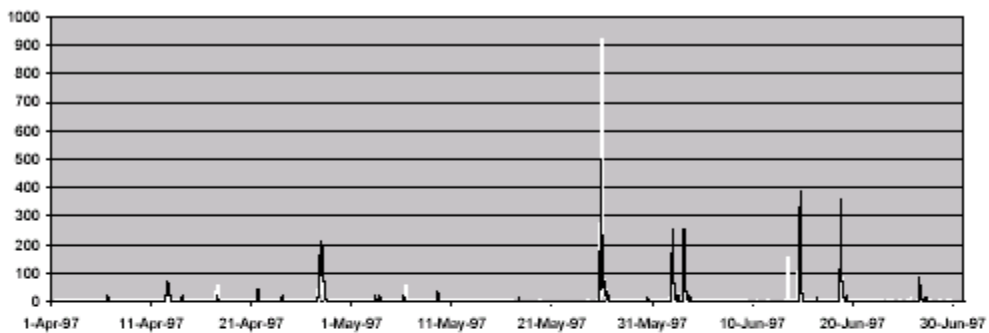
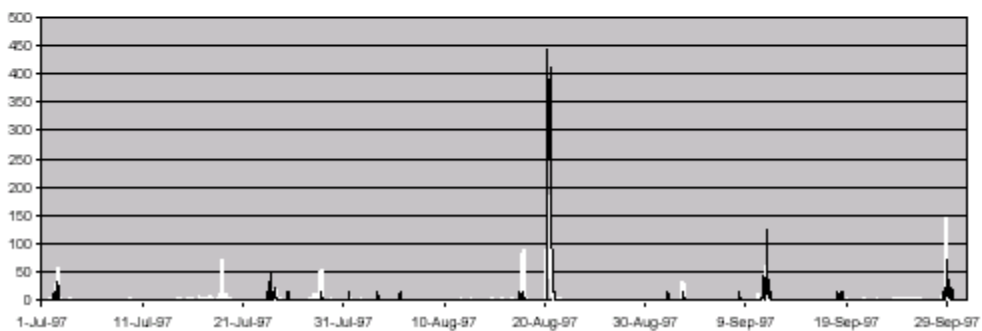
## Time series of HEC-6 modeled and observed flow at USGS Gage for WY 1993 and 1997

The modeling exercise confirmed that instantaneous flows had very severe impacts upon Watts Branch. The peak instantaneous flows could be two orders of magnitude greater than the daily flow. Because the DOH sampling data for the stream did not capture a significant number of peak flow events there was no TSS data with which to calibrate the model at the extreme flows. Regression techniques were used to provide a range of estimates of TSS carried at the higher peak flow events.

During the water year 1997 months of April through October there were 12 flow events greater than 100cfs and 9 of those were greater than 200cfs. For the same period of water year 1993 there were 19 flow events greater than 100 cfs and 13 greater than 200 cfs. There are about two events per year with flow that approach or exceed 1,000cfs . Averaging these two years together gives the following estimates of Channel erosion sediment loads.
